**Flood Control Project Maintenance
Levee Inspections**

Maintenance Issue Types Only, Levee Inspection Report By Mile - Fall 2015

Reclamation District No. 0349 Sutter Island

Waterway	Bank	Unit Miles	Inspection Start/End	Inspector
Unit No. 01 Sacramento River	Right	1.59	10/09/2015 10/09/2015	Herman Phillips

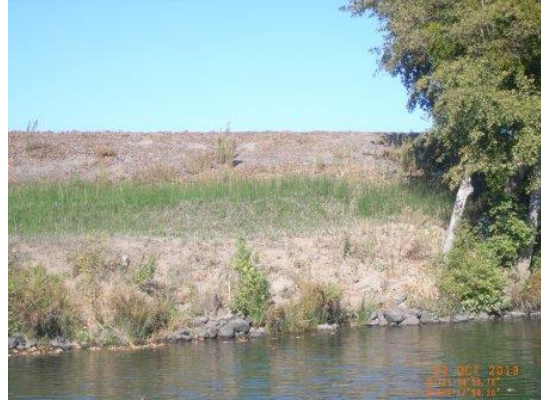
Photo 1 of 1 : USACE2013A_STM_25-5_R_7.jpg

LM Start	0.60	Rating **	M	Issue No.	13
LM End	0.72	Issue Type +	Ma	Location *	WS
Category	Supplemental			GPS Latitude/Longitude	
				Start	End
Item	2015 USACE Erosion Survey, DRAFT			38.298897 °	38.297384 °
				-121.581571 °	-121.582176 °
DWR ID					
Action/Comments					
Inspector Comments: 2010 - Small maintenance, erosion into the toe. 2011 - Minor new erosion at toe. 2015: Minor new erosion at toe, new tree popout. [2015 Site ID: STM_25-5_R]

USACE 2013 Photo #1

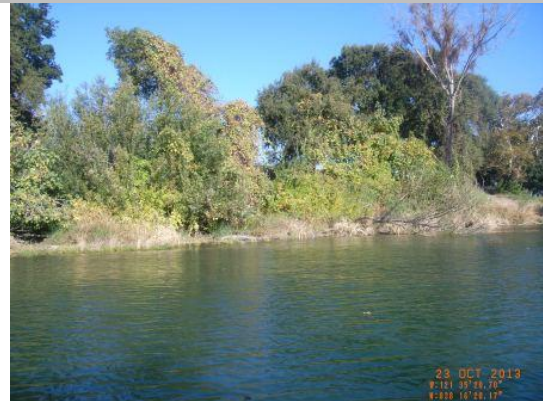
Photo 1 of 2 : USACE2013A_STM_23-6_R_4.jpg

LM Start	2.56	Rating **	M	Issue No.	3
LM End	2.69	Issue Type +	Ma	Location *	WS
Category	Supplemental			GPS Latitude/Longitude	
				Start	End
Item	2015 USACE Erosion Survey, DRAFT			38.273854 °	38.271998 °
				-121.588745 °	-121.589424 °
DWR ID					
Action/Comments					
Inspector Comments: 2011 - Toe scour at the tidal zone. 2015: New tree popout and minor new erosion. [2015 Site ID: STM_23-6_R]

USACE 2013 Photo #1

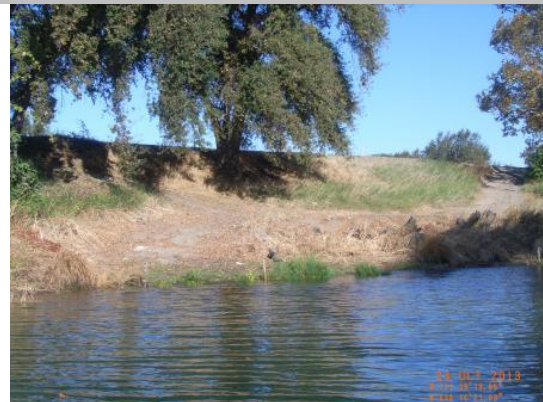
Photo 2 of 2 : USACE2013A_STM_23-6_R_5.jpg

USACE 2013 Photo #2
